October 14, 2022

### 1335 Stelly's Cross Road Assessment Letter

Corvidae Project No.  
COR-2022-153

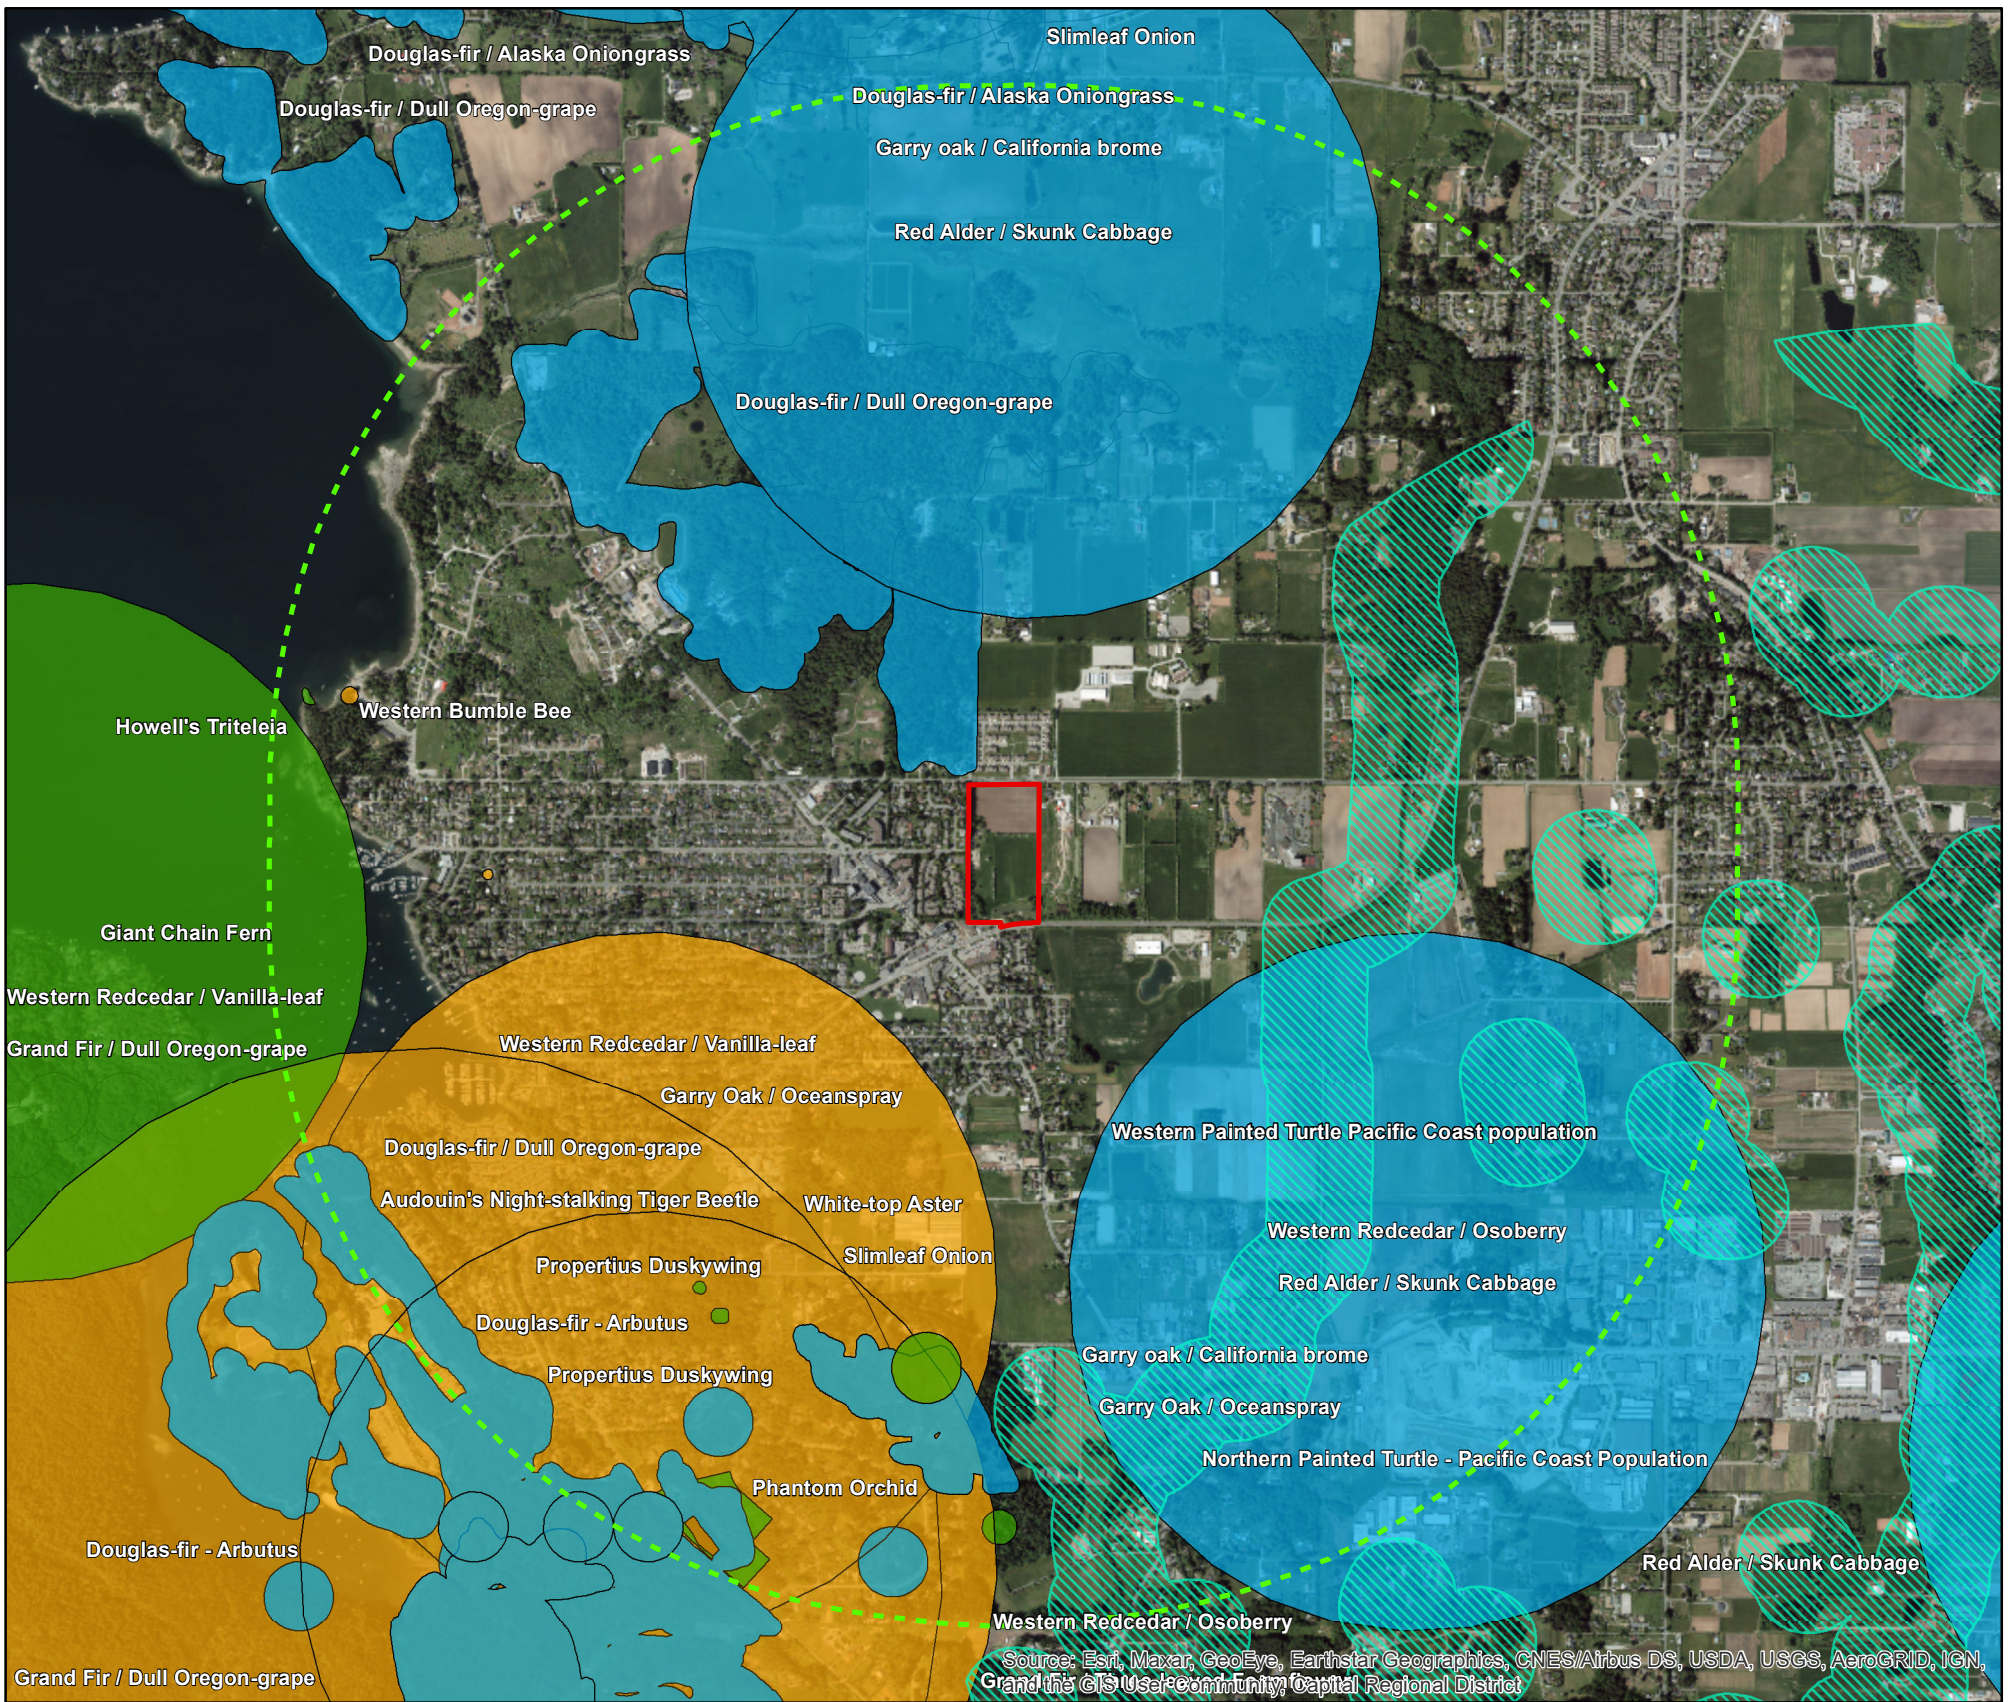
**Figure 2 - CDC Species at Risk**

The QEP confirmed there were no raptor nests on the site. The area is a hayland, with shrubs along the boundaries of the hayfield; in addition to a farmhouse, yard and a poplar tree stand to the west. For all clearing, Corvidae recommends no clearing within the migratory bird window (March 15 to August 15). There were no signs of species at risk on site, and the Conservation Data Centre mapping (Figure 2) shows no species at risk in the project area.

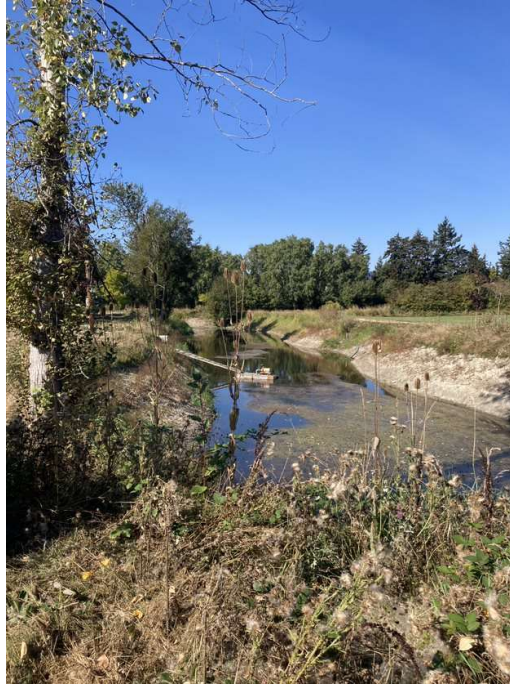
There is a man-made dugout on the property. The QEP confirmed the dugout is not connected to a watercourse or wetland; there is greater than 3 m of space between the top of water level and the ground surface. During the assessment, it was confirmed that there are no surface watercourse running into the dugout. This dugout, due to lack of connectivity and it being ex nihilo (out of nothing) is not protected under the RAPR or WSA.

Photo 1. View looking west at man-made dugout. September 21, 2022

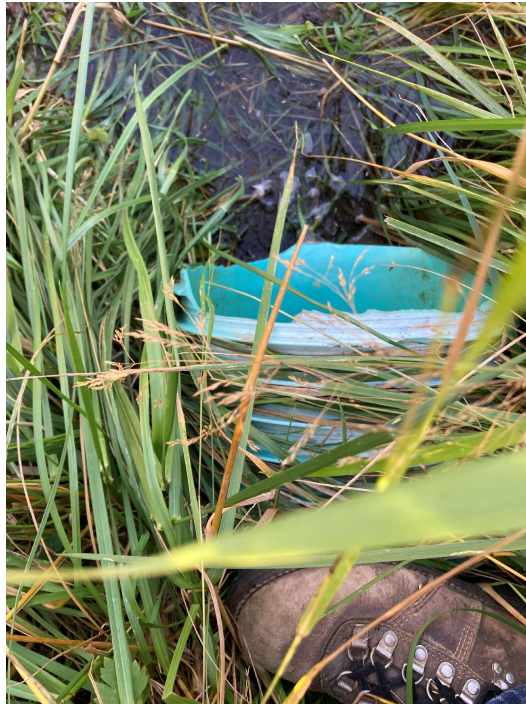
Photo 2. View looking at the culvert at the downslope edge of the dugout, located 3 m above the water level, with water draining from the roadside ditch into the dugout. September 21, 2022.

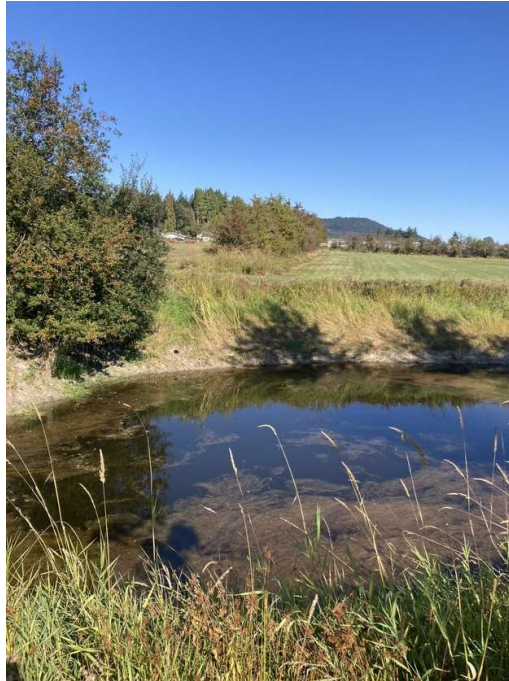
**Photo 3. View looking north at dugout area. September 21, 2022.**

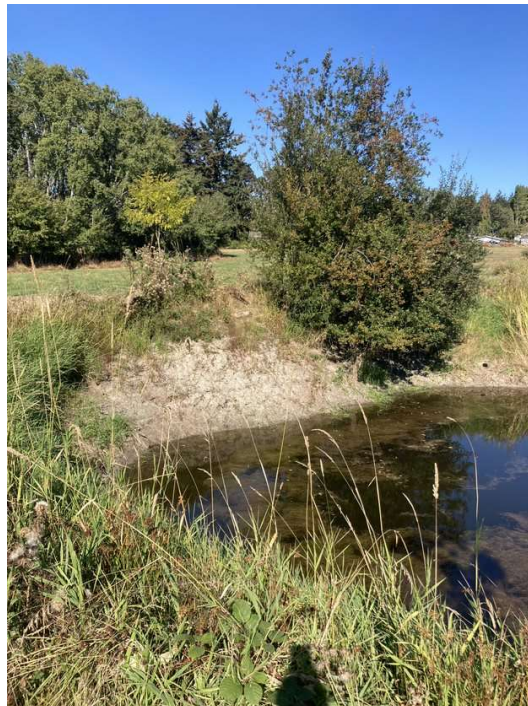
**Photo 4. View looking west to end of dugout, culvert in grass to the left. September 21, 2022.**

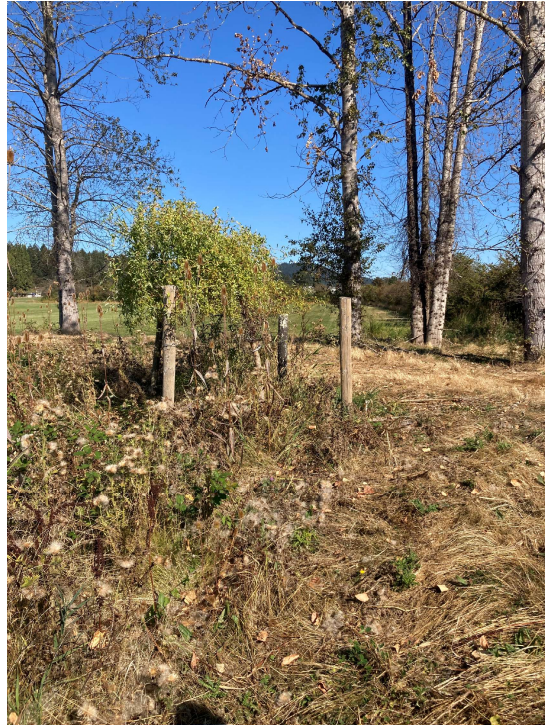
The Central Saanich mapping systems shows a large wet area along the south boundary of the property. The QEP was on site and confirmed that this area is dry, with the exception of the isolated dug-out. Photo 5 shows the area where the Central Saanich map shows a wetted polygon. This vegetation is dry, upland vegetation. The soil is also a dry, un-gleyed soil, indicating it is a dry site.

**Photo 5. Grassland and standing trees, with upland habitat features in the area that was mapped as potentially wet. September 21, 2022.**

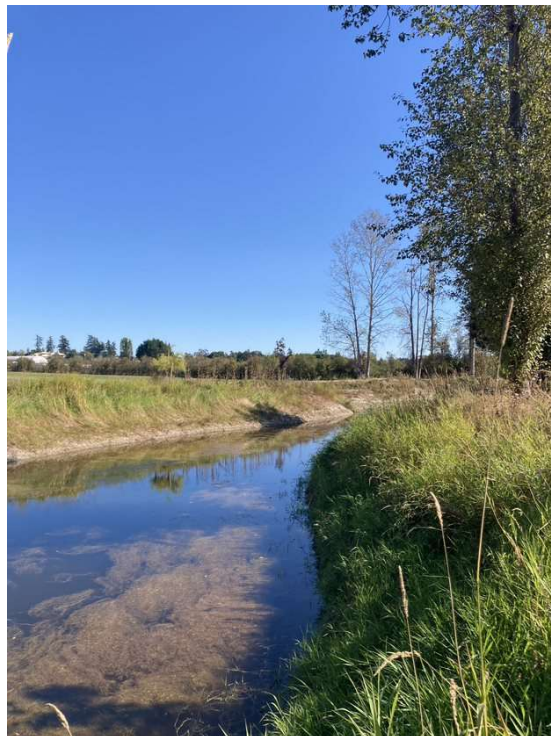
**Photo 6. View looking east at the man-made dugout, culvert in the grass. September 21, 2022**
